**CLEVITE7**<sup>®</sup>  
ENGINE BEARINGS

Clevite 77<sup>®</sup> Issue  
Form # CL77-3-402

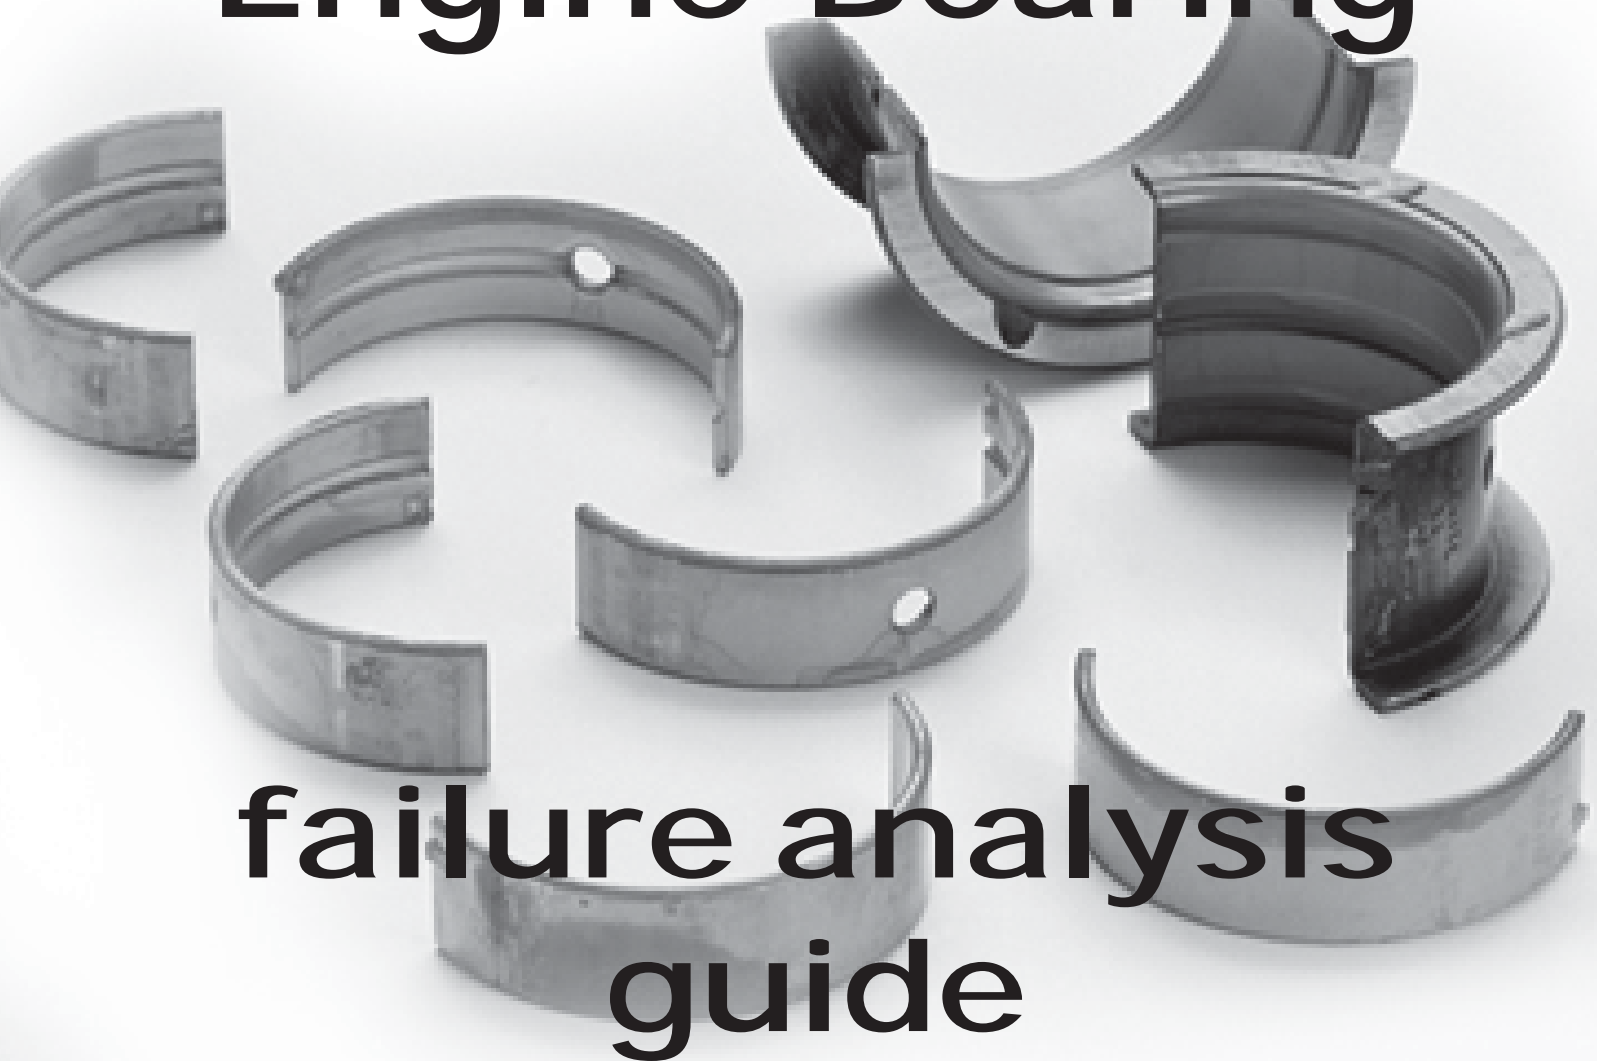
## failure analysis guide

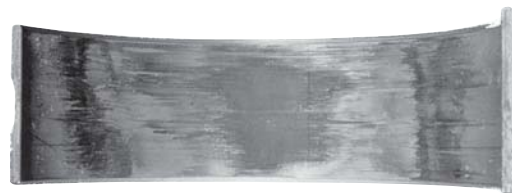
**CORROSION ..... PAGE 18**

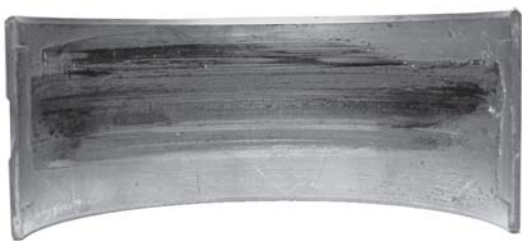
**OIL STARVATION ..... PAGE 15**

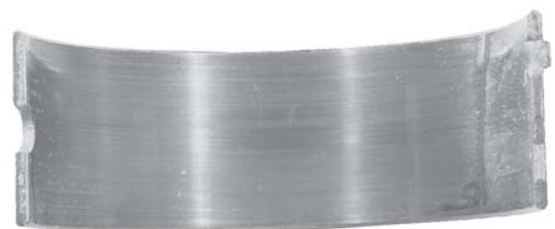
**ACCELERATED WEAR ..... PAGE 19**

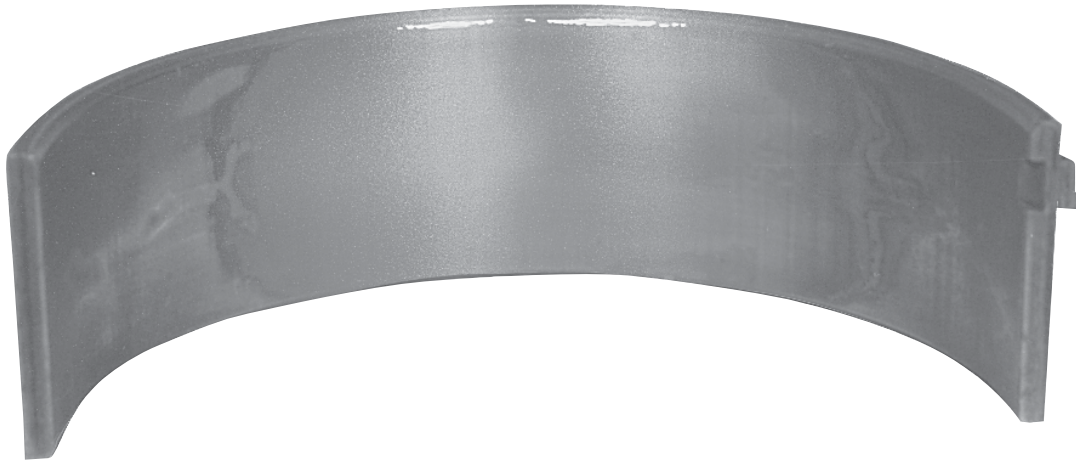
Uniform wear pattern over approximately 2/3 of the bearing's surface. Wear should diminish near the parting line ends of the bearing, and the wear pattern should extend uniformly across the bearing in the axial direction.

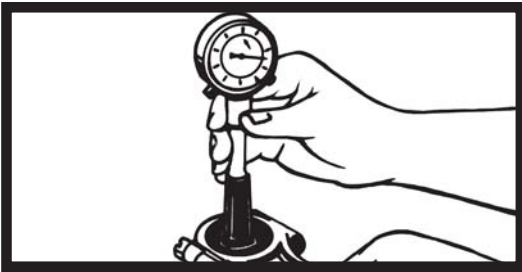
1. Check all connecting rod housing bores for taper, roundness and size, using a bore gauge or inside micrometer. Check for parallelism between the large and small ends of rod. Check condition of bolts and threads.

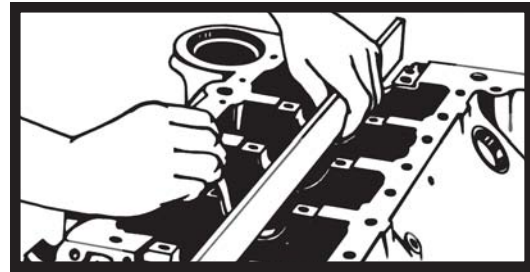
2. Check main bearing bores for alignment, taper, roundness and size. Check condition of bolts and threads.

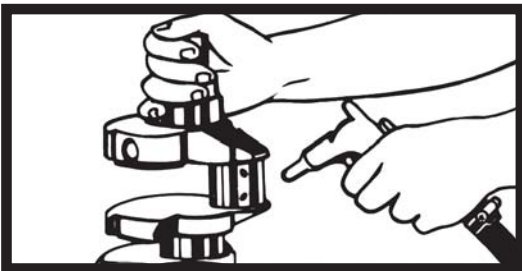
3. Make sure that engine block and crankshaft are clean, checking oil passageways for hidden dirt and debris. Hot water and detergent work best for cleaning.

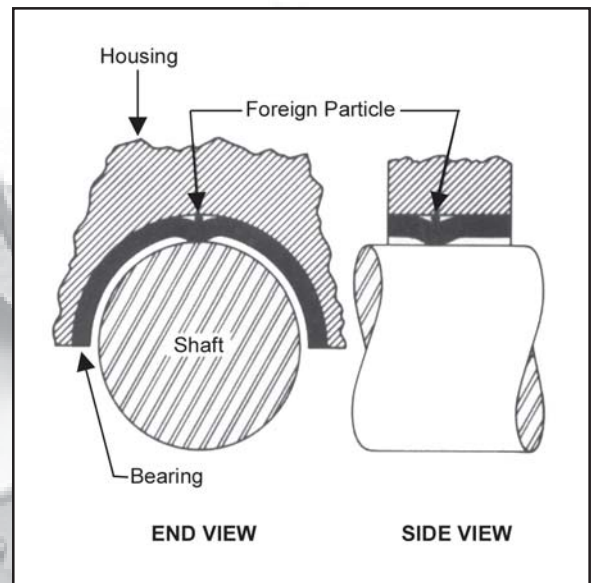
Engine bearings will not function properly if they are installed wrong. In many cases, misassembly will result in premature failure of the bearing.

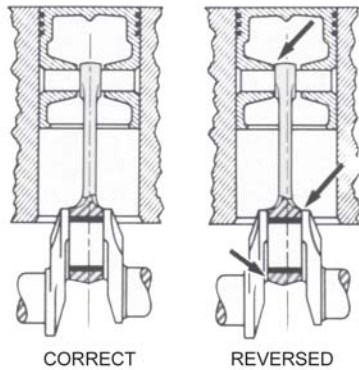
Position of Offset  
Connecting Rod Reversed

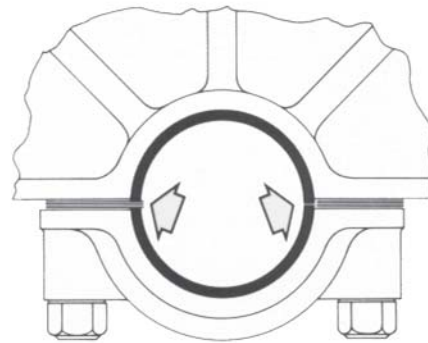
Shims Improperly  
Installed

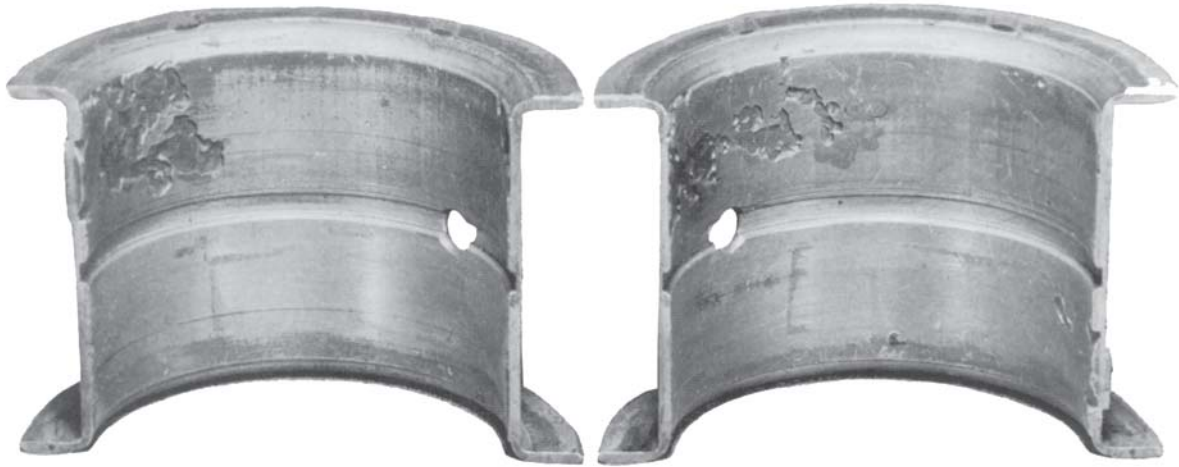
Bearing Oil Hole  
Not Aligned With Oil  
Passage Hole

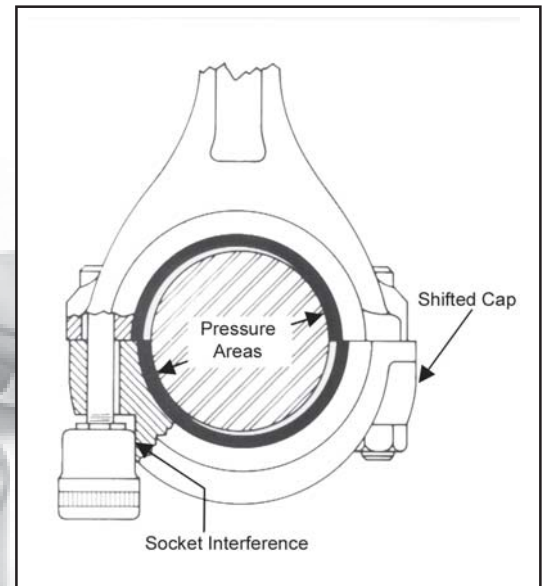
## CORRECTIVE ACTION

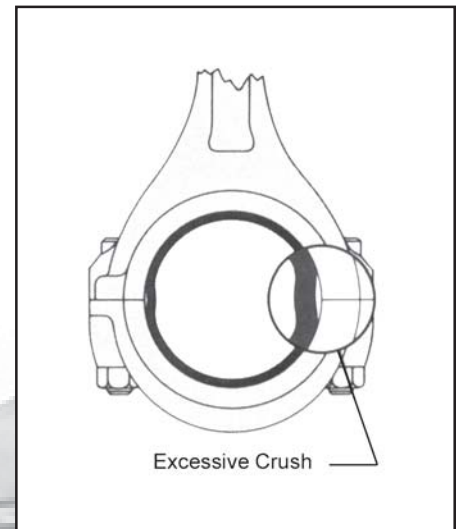
When there is too much crush, however, the additional compressive force created by the surplus crush that still remains after the bearing is fully seated causes the bearing to bulge inward at the parting faces. This bearing distortion is called “side pinch.”

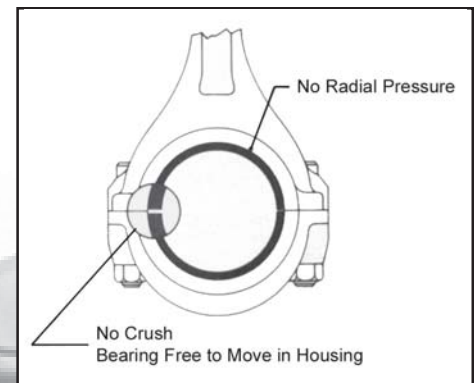
Because of the loss of radial pressure, there is inadequate contact with the bearing housing, thus impeding heat transfer away from the bearing. As a result, the bearing overheats causing deterioration of the bearing surface.

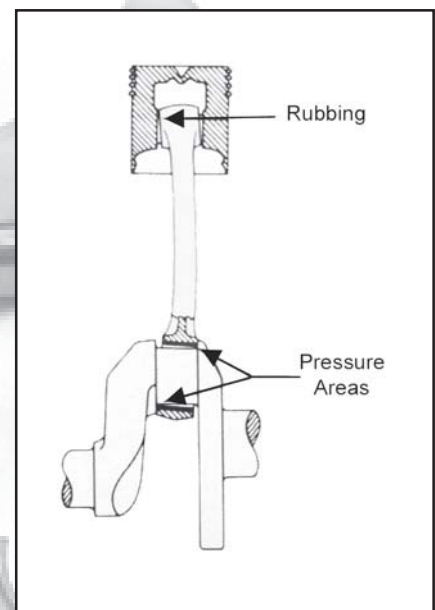
1. Inspect connecting rod and recondition or replace if bent or twisted.
2. Check journal surfaces for excessive wear and regrind if necessary.
3. Install bearing.
4. Avoid dropping or abusing the connecting rod prior to assembly.
5. Use proper installation techniques.
6. Check related upper cylinder parts and replace if necessary.

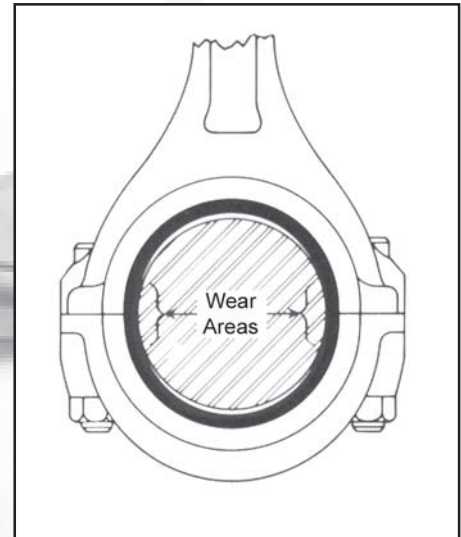
1. Check the roundness of bearing housings before installing the new bearings. If they are found to be out-of-round, recondition the bearing housings (or replace connecting rod).
2. Check the journal surfaces for excessive wear and regrind if necessary.
3. Install new bearings.

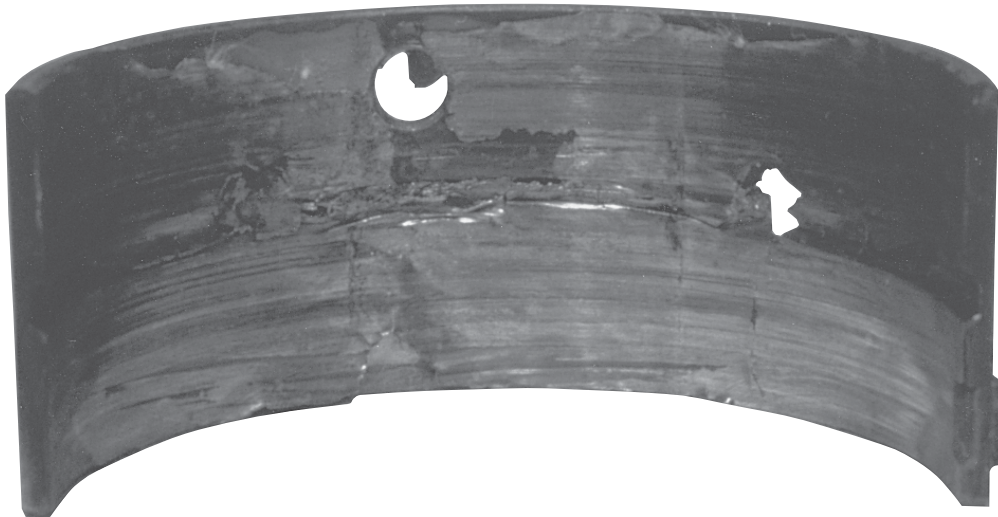
1. Double-check all measurements taken during the bearing selection procedure to catch any errors in calculation. (During assembly check oil clearance with Plastigage<sup>®</sup>.)
2. Check to be sure that the replacement bearing you are about to install is the correct one for the application.
3. Check the journals for damage and regrind if necessary.
4. Check engine for possible blockage of oil passages, oil suction screen and oil filter.
5. Check the operation of the oil pump and pressure relief valve.
6. Be sure that the oil holes are properly indexed when installing the replacement bearings.
7. Advise the operator about the results of engine lugging.
8. Always prime the lubrication system before the engine is started the first time.

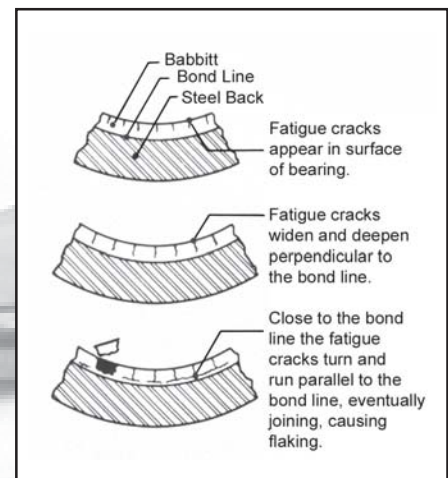
1. If the service life for the old bearing was adequate, replace with the same type of bearing to obtain a similar service life.
2. If the service life of the old bearing was too short, replace with a heavier duty bearing to obtain a longer life.
3. Replace all other bearings (main connecting rod and camshaft) as their remaining service life may be short.
4. Recommend that the operator avoid "hot rodding" and "lugging" as these tend to shorten bearing life.
5. Check for misassembly. Use proper installation techniques.

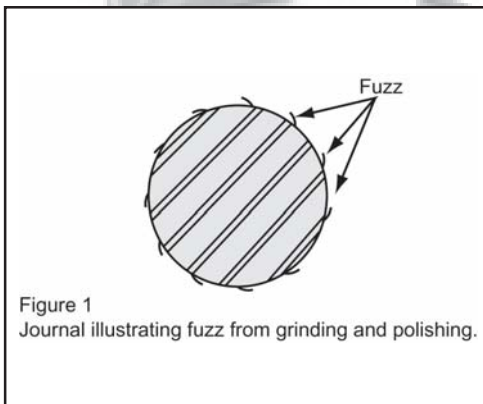
Figure 1  
Journal illustrating fuzz from grinding and polishing.

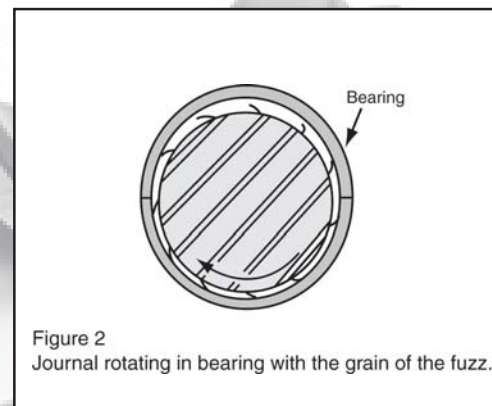
Figure 2  
Journal rotating in bearing with the grain of the fuzz.

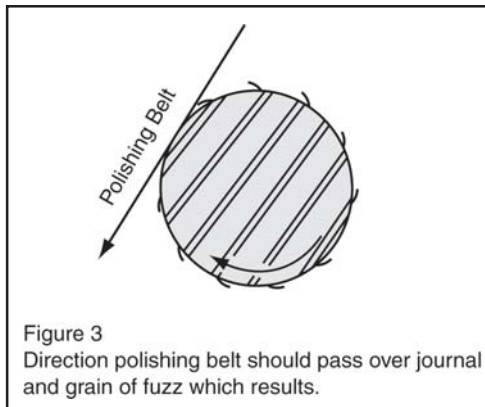
Figure 3  
Direction polishing belt should pass over journal and grain of fuzz which results.

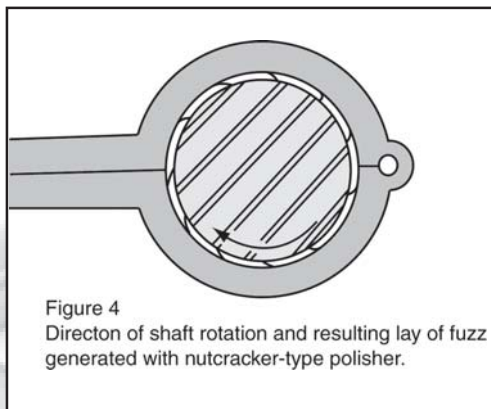
Figure 4  
Direction of shaft rotation and resulting lay of fuzz generated with nutcracker-type polisher.

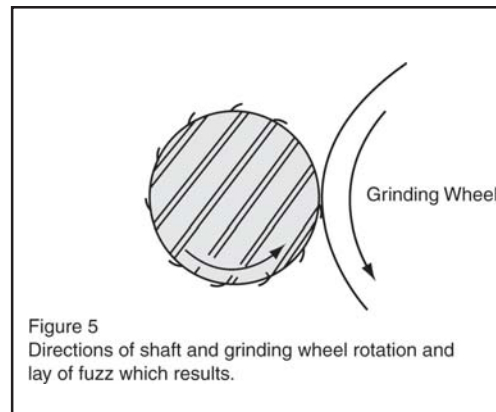
Figure 5  
Directions of shaft and grinding wheel rotation and lay of fuzz which results.

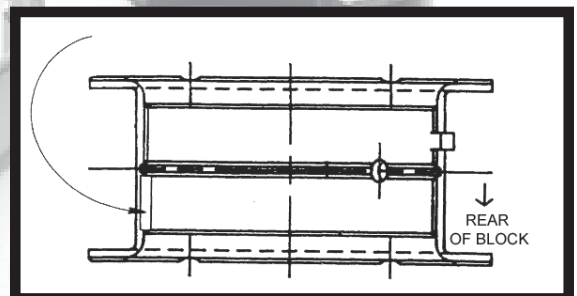
## SEVERE USE RECOMMENDATIONS

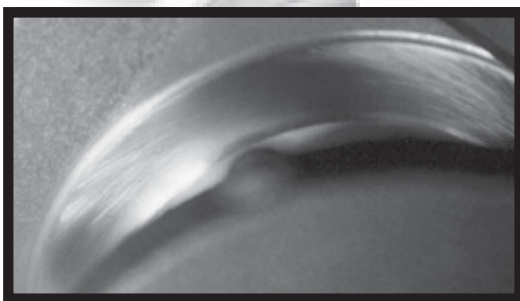
**AVOID - SWIRL PATTERN**

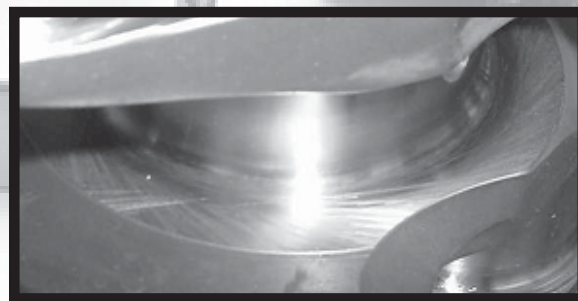
**AVOID - CROSSHATCH PATTERN**
